# NCHRT report 350 Test 3-21 of the Vertical Flared Back Transition

PUBLICATION NO. FHWA-RD-99-062

DECEMBER 1999

16. Abstract  <p>Few transitions have been tested to NCHRP Report 350 standards. Officials at FHWA decided that the W-Beam with W-Beam Rub Rail and Steel Posts Transition to the Vertical Flared Back Concrete Bridge Rail should be tested to test level three (TL-3). The test performed (test designation 3-21) involves the 2000P (pickup truck) traveling at a nominal speed and angle of 100 km/h and 25 degrees impacting the critical impact point. This test is intended to evaluate the strength of the section in containing and redirecting the pickup truck.</p> <p>This report presents the details and results of NCHRP Report 350 test designation 3-21 for evaluation of the W-Beam with W-Beam Rub Rail and Steel Posts Transition to the Vertical Flared Back Concrete Bridge Rail to TL-3. The W-Beam with W-Beam Rub Rail and Steel Posts Transition to the Vertical Flared Back Concrete Bridge Rail did not meet required criteria K and F of NCHRP Report 350 test designation 3-21.</p>

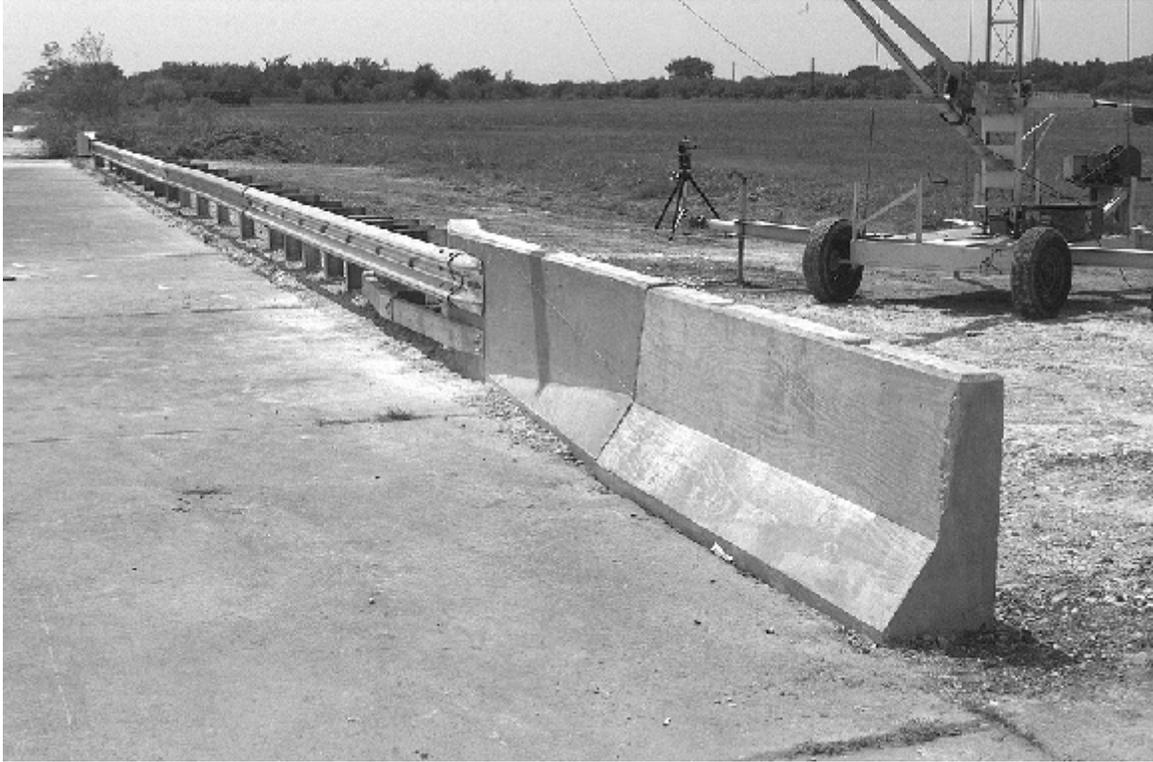
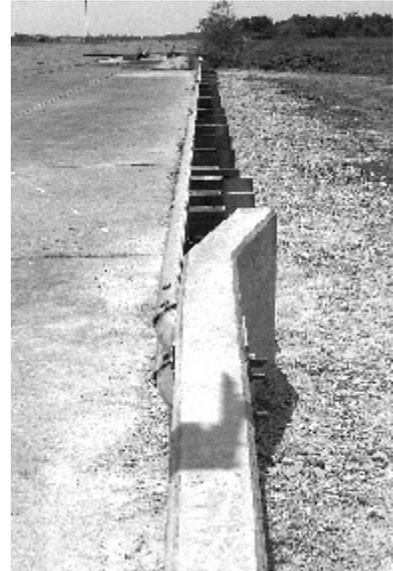
Figure 5. Vertical flared back transition before test 404211-4.

The test installation consisted of a portion of simulated bridge rail, a wingwall, a transition, a length of approach guardrail, and a guardrail terminal.

This test was performed on the W-Beam with W-Beam Rub Rail and Steel Posts Transition to the Vertical Flared Back Concrete Bridge Rail. Drawings for this transition are presented in figures 1 through 4, and photographs of the test installation are shown in figures 5 and 6.

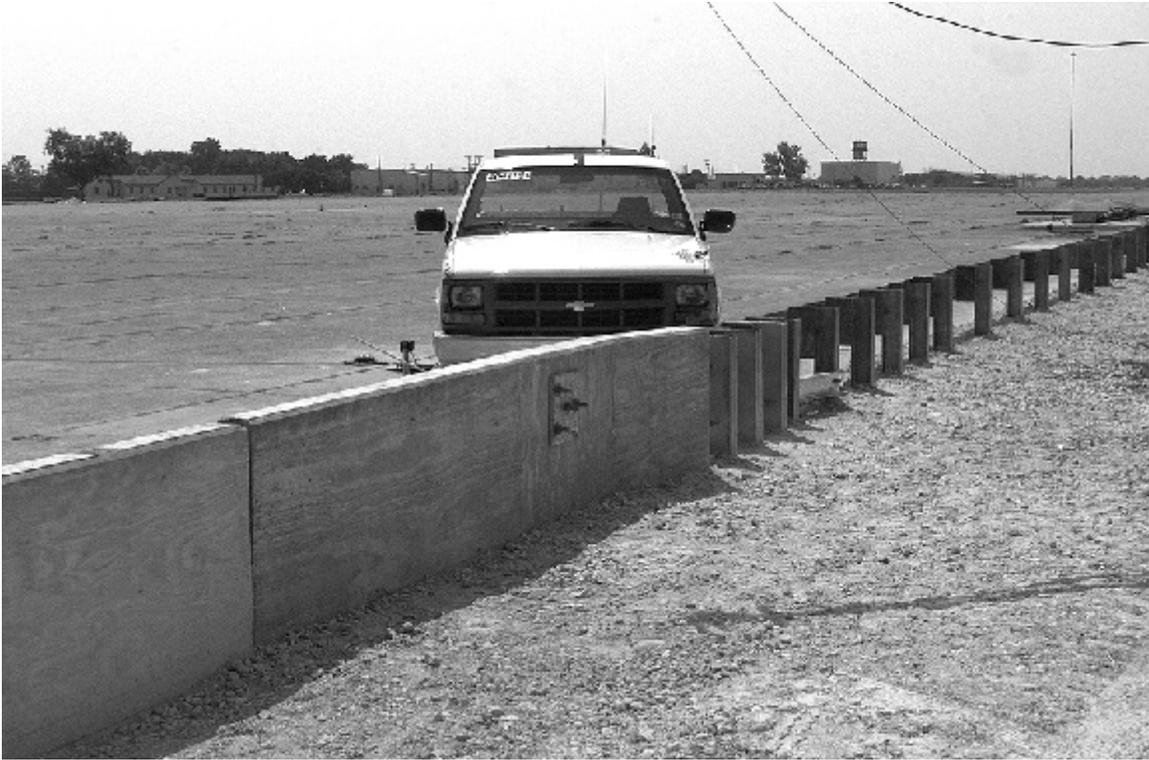
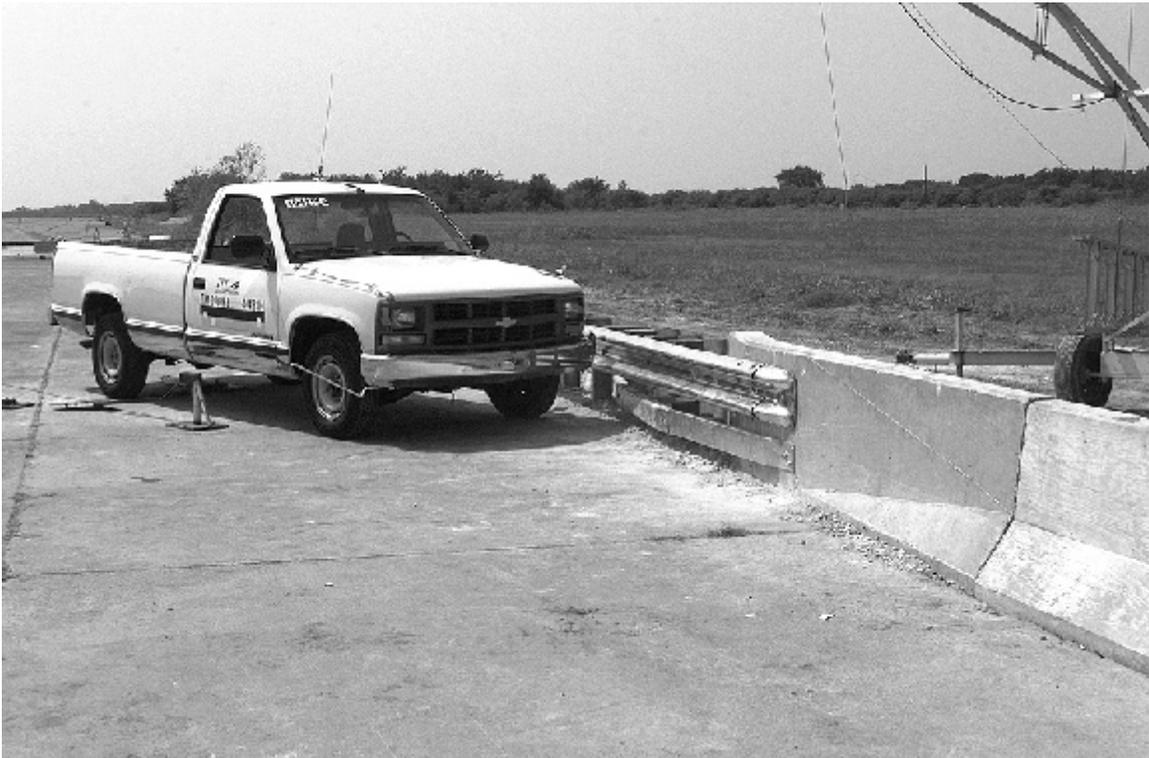
Figure 7. Vehicle/installation geometrics for test 404211-4.

A 1994 Chevrolet 2500 pickup truck, shown in figures 7 and 8, was used for the crash test. Test inertia weight of the vehicle was 2000 kg, and its gross static weight was 2074 kg. The height to the lower edge of the vehicle bumper was 380 mm and it was 600 mm to the upper edge of the bumper. Additional dimensions and information on the vehicle are given in figure 9. The vehicle was directed into the installation using the cable reverse tow and guidance system, and was released to be free-wheeling and unrestrained just prior to impact.

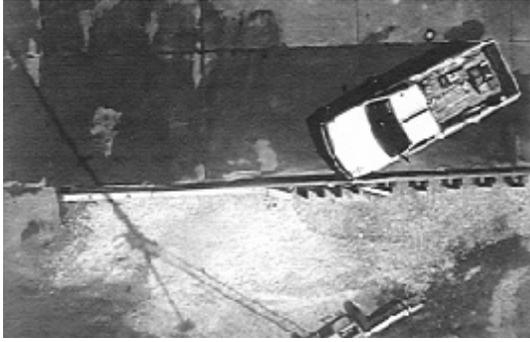
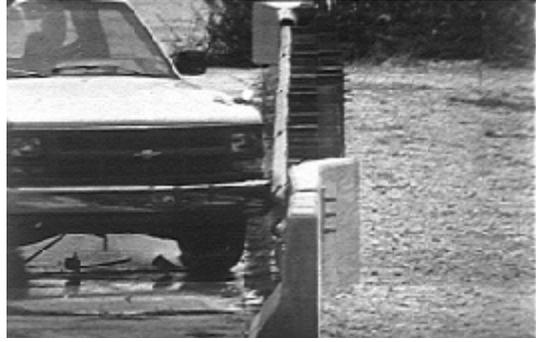
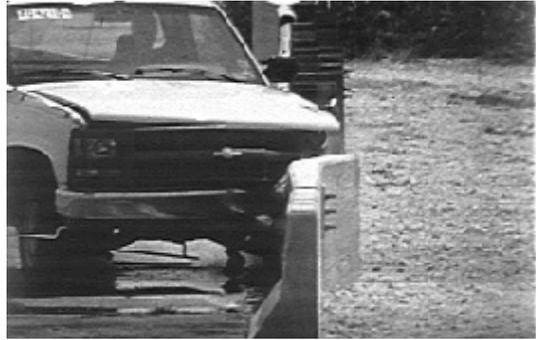
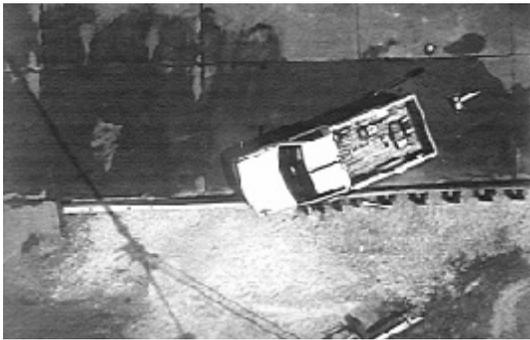
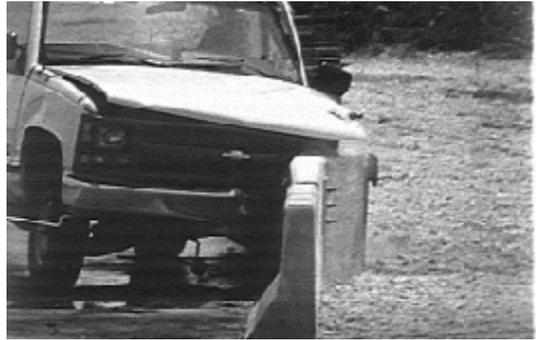
Figure 10. Sequential photographs for test 404211-4 (overhead and frontal views).

The vehicle, traveling at 101.2 km/h, impacted the vertical flared back transition 0.69 m from the end of the bridge parapet at a 24.7-degree angle. Shortly after impact, posts 4, 3, and 2 moved, followed by movement at posts 1 and 5. At 0.052 s, redirection of the vehicle began. The concrete parapet moved at 0.058 s and the driver's side window shattered at 0.108 s. The right front and left rear tires lost contact with the ground at 0.102 and 0.183 s, respectively. At 0.170 s, the right rear tire lost contact with the ground. The vehicle, traveling at 80.2 km/h, was parallel to the installation at 0.173 s. At 0.174 s, the rear left side of the vehicle contacted the rail element between posts 3 and 4. At 0.304 s, the rear left tire lost contact with the concrete parapet and the left rear tire lost contact with the ground. The vehicle lost contact with the concrete parapet at 0.399 s, and was traveling at 75.7 km/h and an exit angle of 5.2 degrees. After exiting the transition, the vehicle yawed clockwise and rolled counterclockwise. The vehicle subsequently rolled one revolution and came to rest upright 56.4 m down from the point of impact and 9.9 m toward traffic lanes. Sequential photographs of the test period are shown in figures 10 and 11. Brakes on the vehicle were applied 8.3 s after impact.

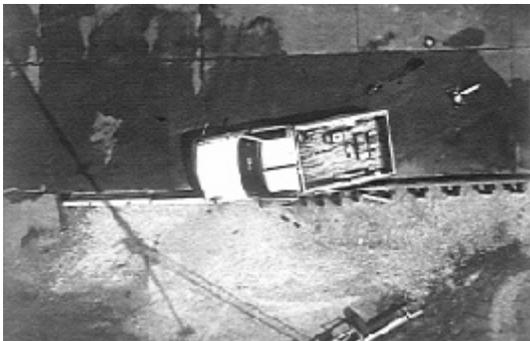
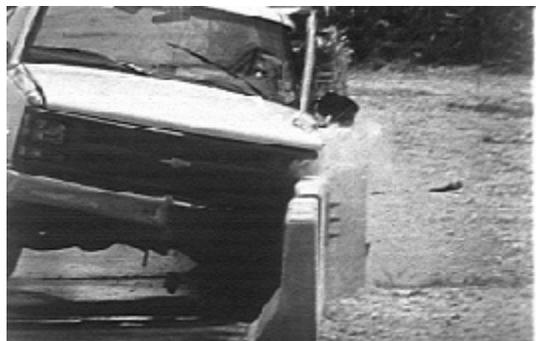
0.149 s

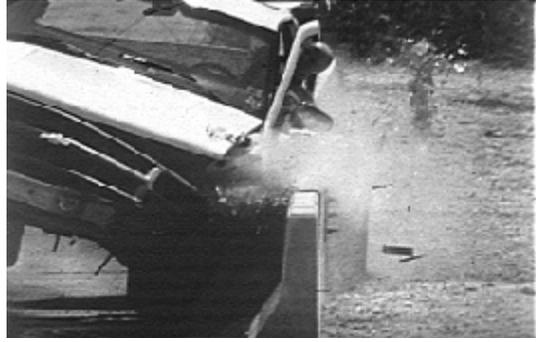
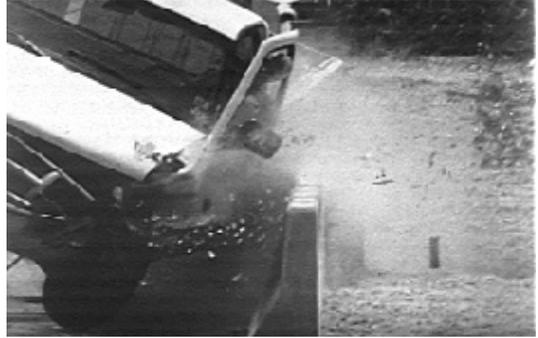
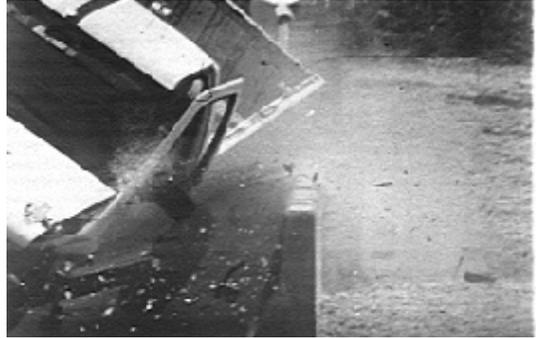
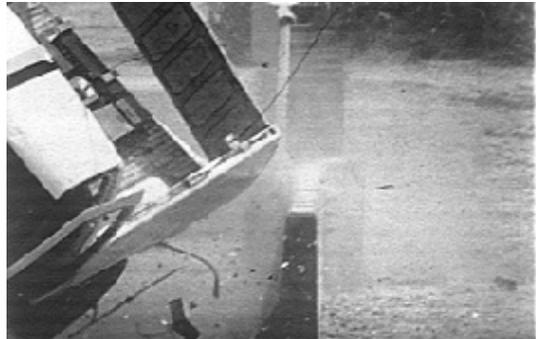
Figure 10. Sequential photographs for test 404211-4 (overhead and frontal views) (continued).

0.223 s

0.297 s

0.396 s

0.545 s

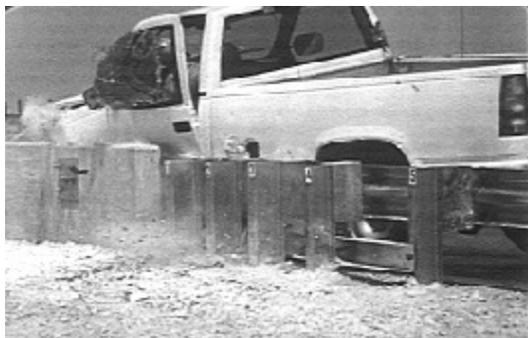
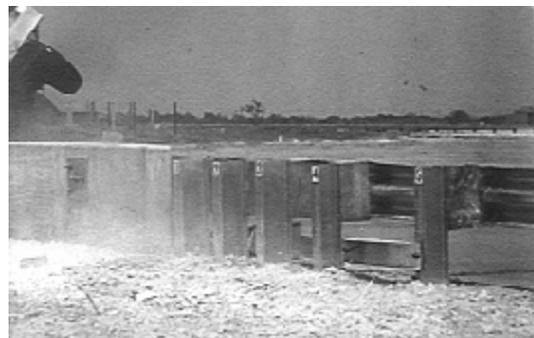
Figure 11. Sequential photographs for test 404211-4  
(rear view).

0.396 s

0.149 s

0.545 s

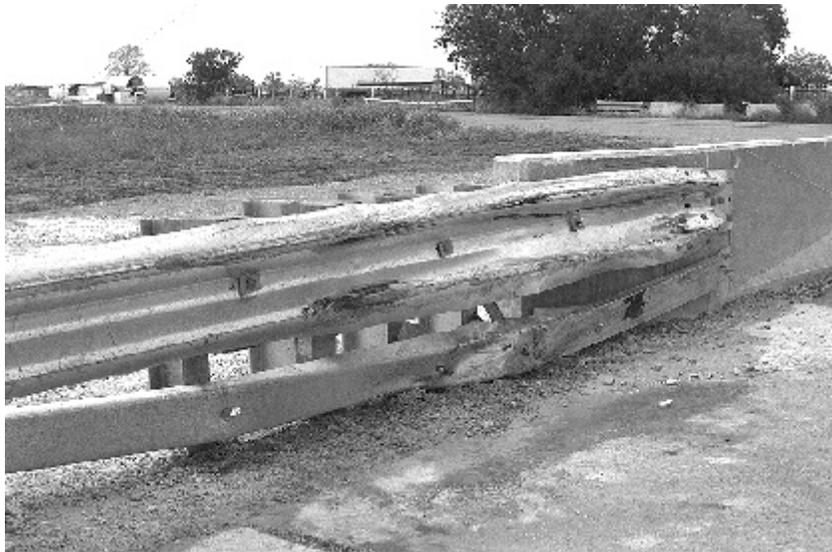
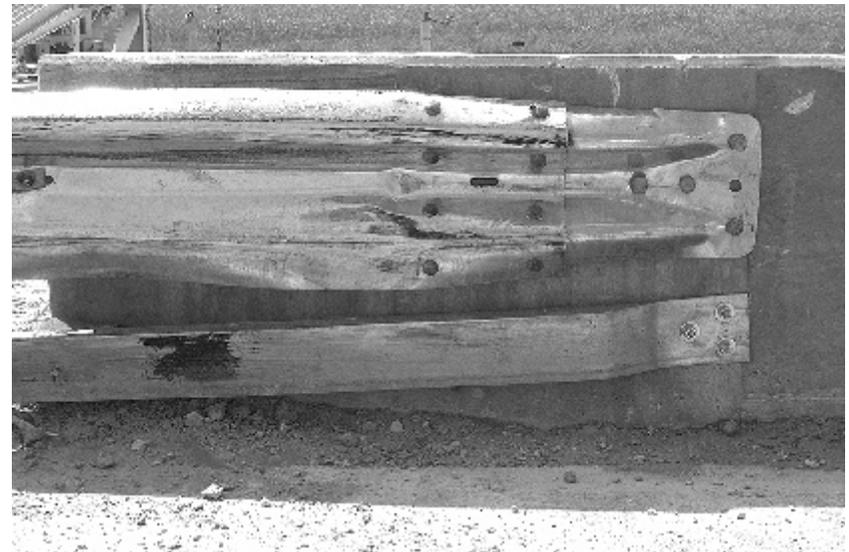
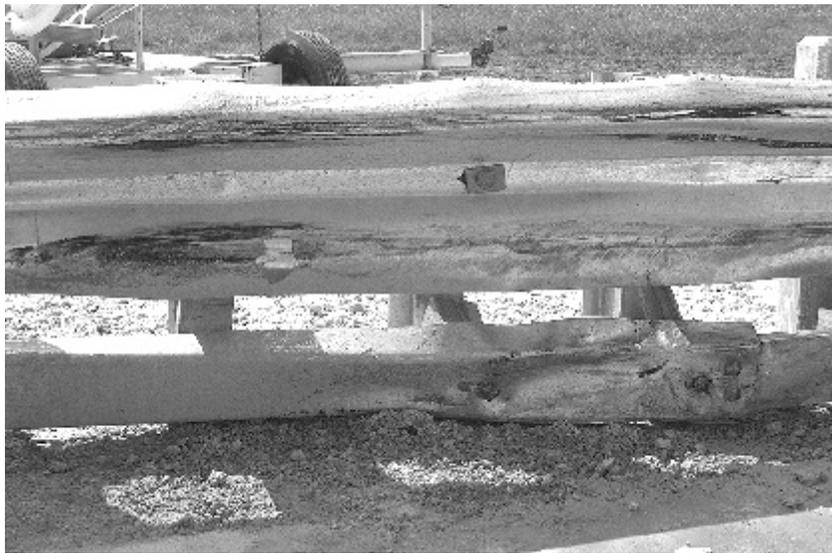
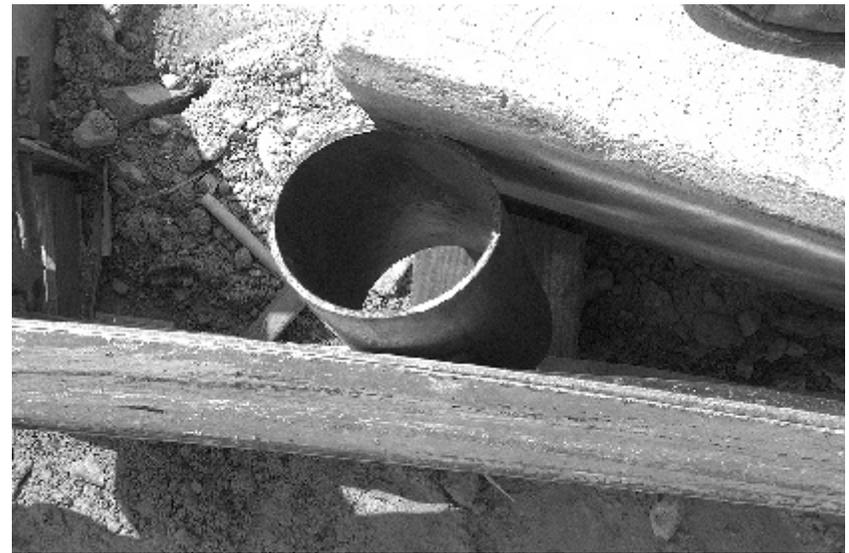
Figure 13. Installation after test 404211-4.

The vertical flared back transition received moderate damage as shown in figures 12 and 13. Deformation to the upper and lower W-beams extended from post 5 through post 1. The bolt was out of posts 1 and 2 at the bottom blockout. Also at post 2, the rub rail was deformed outward. At post 3, the rub rail was twisted. The spacing between the metal pipe and blockout and the concrete parapet was 45 mm before the test and after the test the pipe was leaning against the parapet and the spacing was 15 mm. The concrete parapet was pushed back 25 mm. Total length of contact of the vehicle with the transition and concrete parapet was 3.91 m.

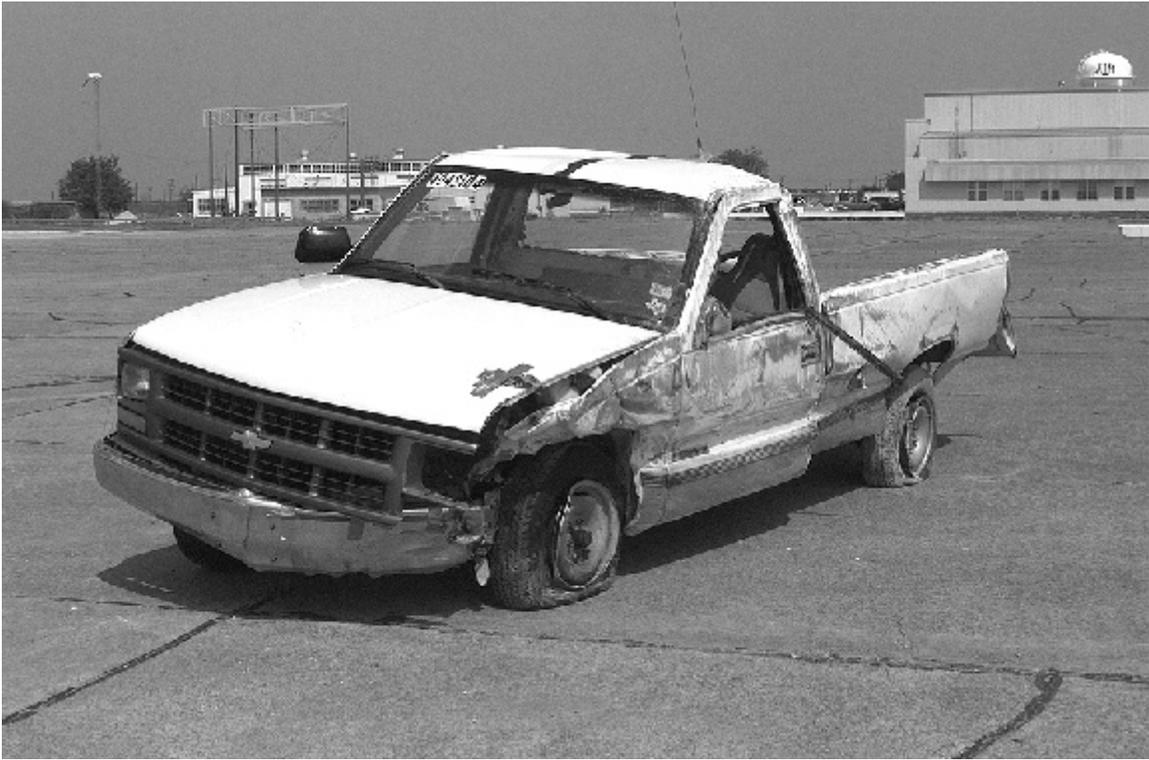
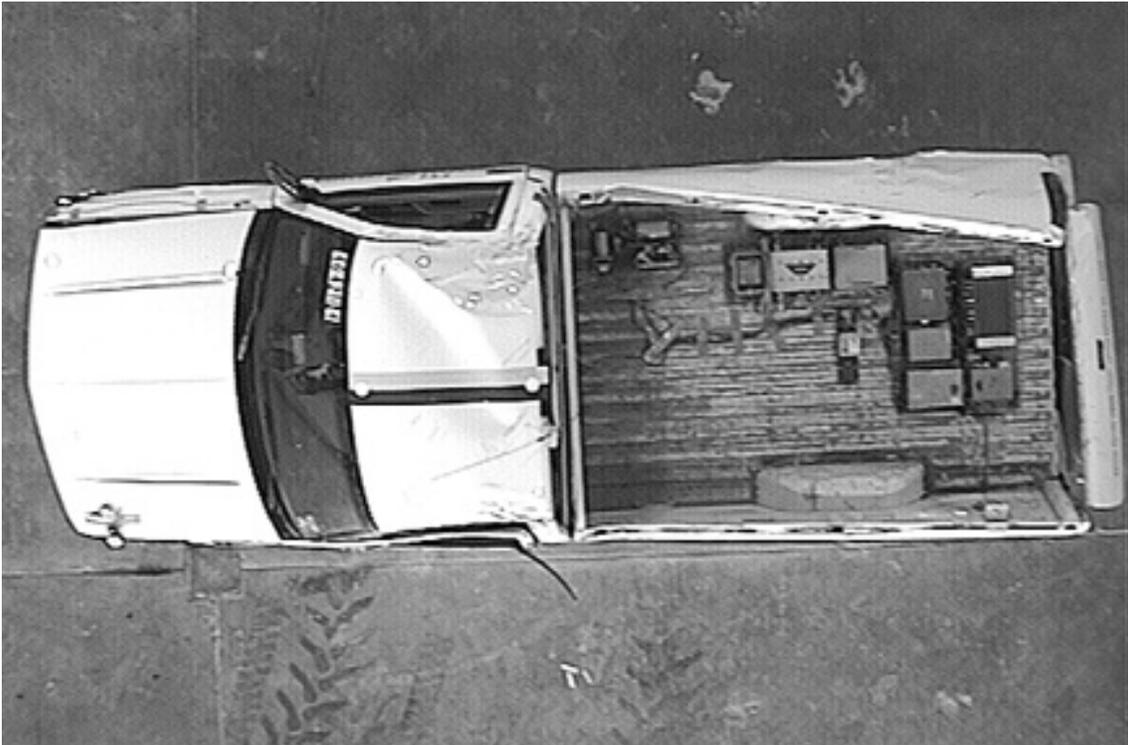
Figure 14. Vehicle after test 404211-4.

The vehicle sustained substantial damage as shown in figure 14. The upper and lower A-arms and frame rail were all severely damaged. Both left-side quarter panels were damaged and the left door had a gap (not measurable). The right door, front and rear rims, and the rear quarter panel sustained damage. Also damaged were the rear bumper and tail gate. The front bumper, grill, hood, radiator, fan, and cab were deformed. The windshield and the right, left, and rear glasses were shattered. As shown in table 2, maximum exterior crush to the vehicle was 530 mm at the front bumper and 410 mm above the front bumper. Maximum deformation of the occupant compartment was 75 mm (7-percent reduction in space) in the center floor pan area and 27 mm (2-percent reduction in space) in the firewall area. Details can be found in table 3. The interior of the vehicle is shown in figure 15.
